# Designated Substances Survey

**St. Mary Catholic  
Elementary School**

**35 Centre Street,  
Campbellford, Ontario**

January 21, 2026

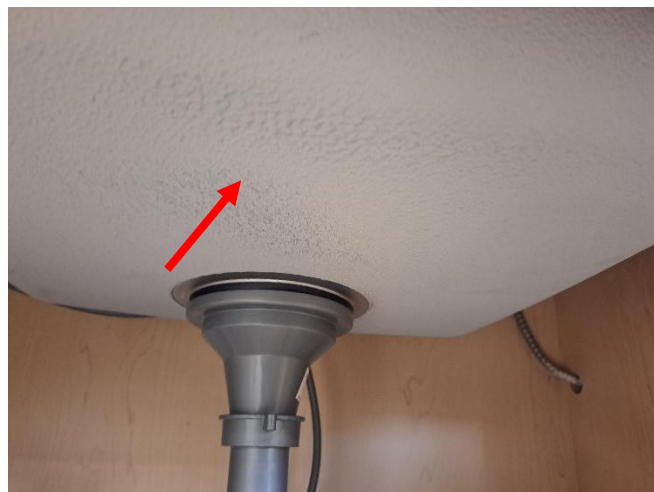
**Photo 1:** View of the non-asbestos containing white sink coating (see arrow) observed within Classroom 227.

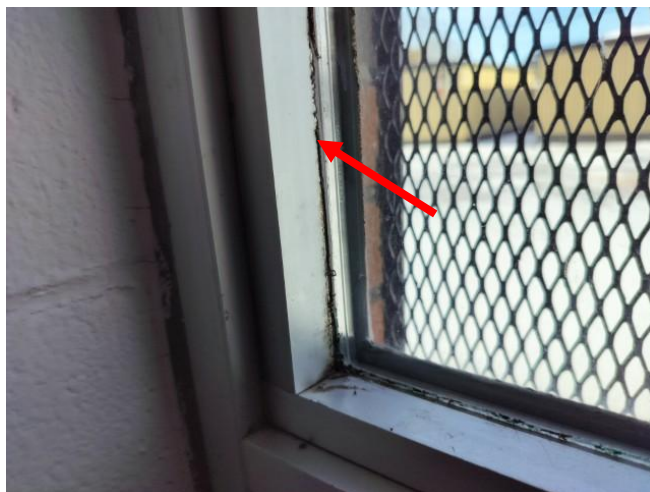
| Hazardous Material | Findings |
|---|---|
| Asbestos | Grey Window Glaze was sampled from the interior windows dated from 1984 within the Subject Building (Sample Nos. 1984-GLZ-01a to 1984-GLZ-01c) and Sample No. 1984-GLZ-01b was identified to contain <b>6% Chrysotile</b> asbestos by laboratory analysis. Based on the result, all grey window glaze on interior windows dated from 1984 within the Subject Building should be considered asbestos containing. At the time of site visit, approximately 500 linear feet of the asbestos containing grey window glaze was observed to be in good condition. |

**Photo 2:** View of the asbestos containing grey glaze (see arrow) observed to be in good condition on the interior windows dated from 1984.

- Grey window glaze; and
  - Gold sink coating.
- 2) S2S recommends that the following asbestos containing materials identified in Table 2 be managed in place or removed following Type 2 asbestos abatement procedures in accordance with O. Reg 278/05:

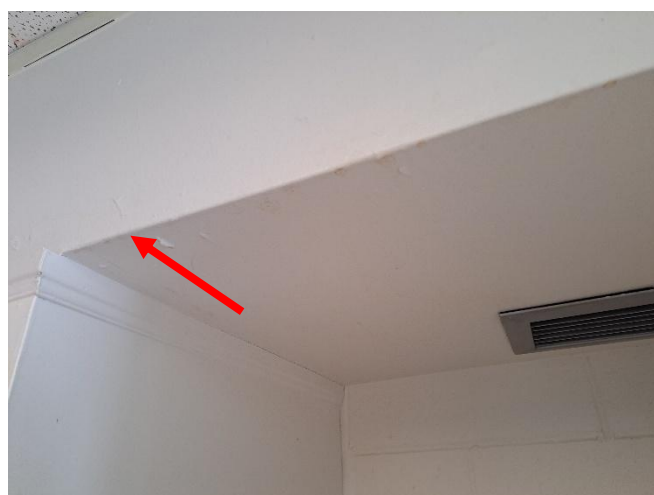
**Photo 3:** View of the drywall finishes (see arrow) associated with non-asbestos containing drywall joint compound observed on the bulkhead in the corridor near Room 203.

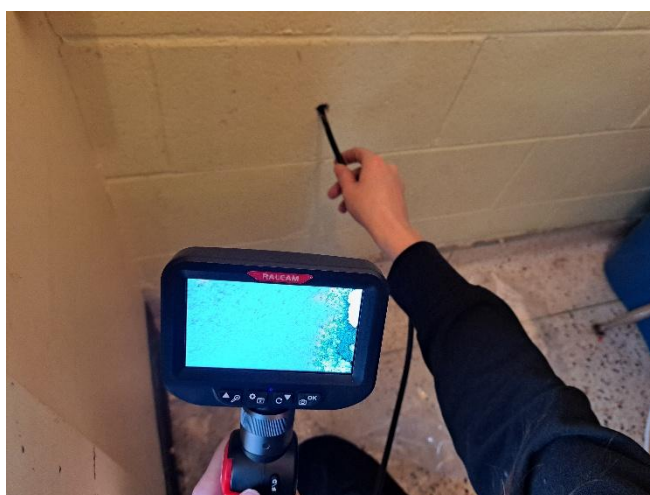
| Hazardous Material | Findings |
|---|---|
| | During the site visit, wall cavities were investigated throughout representative locations within the 1956, 1965, and 1979 sections of the Subject Building to determine the presence or absence of vermiculite. Drill holes, where required, were made to provide visual access with a borescope. Upon completion of the investigation, it was determined that no evidence of vermiculite materials was observed or presumed to be present within the Subject Building. |

**Photo 4:** View of the concrete block wall during the vermiculite investigation and drilling activities near Classroom 103. No vermiculite was noted to be present in the wall cavities.

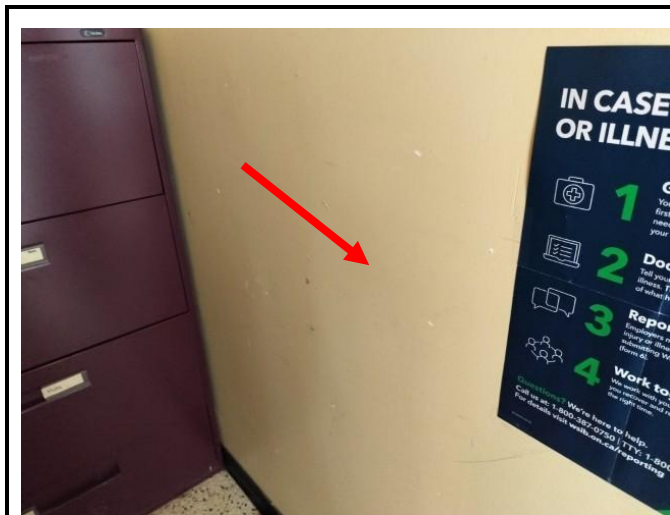
| Hazardous Material | Findings |
|---|---|
| Lead | Pale yellow paint (Sample No. LS-02) collected on the walls of Room 111 was identified to contain <b>28 ug/g lead</b> by dry weight and is therefore identified to be low-level lead containing. At the time of the current site visit, the low-level lead containing pale yellow paint was observed to be in good condition throughout the school. |

**Photo 7:** View of the lead containing pale yellow paint (see arrow) observed in good condition on wall of Room 111.

- 4) Paints identified in Table 2 above were found to contain detectible concentrations of lead. Based on visual observations during the DSS, the identified lead containing paints noted in Table 2 were observed to be in good condition, with the exception of the brown paint on the exterior concrete walls observed to be in poor condition. Paints with similar texture and appearance that are present throughout the Subject Building should be presumed to contain similar concentrations of lead. It is recommended that the poor condition paint be stabilized with fresh paint using appropriate worker protection.

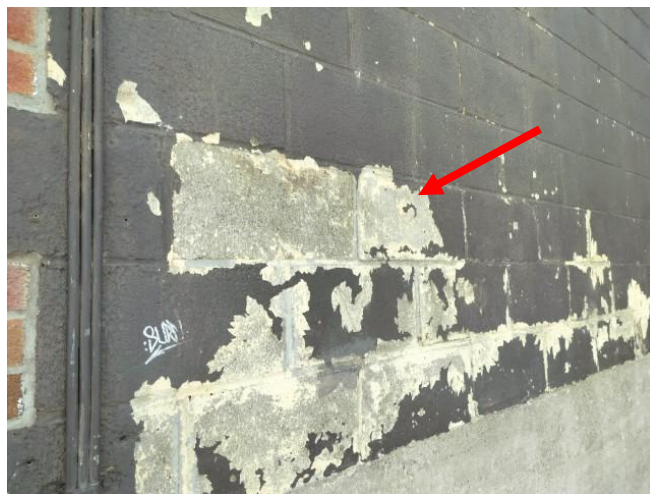
| Hazardous Material | Findings |
|---|---|
| | observed to be in good condition, except for approximately 50 ft <sup>2</sup> that was observed to be in poor condition on the exterior concrete walls. |

**Photo 8:** View of the lead containing brown paint (see arrow) observed in poor condition on the exterior concrete walls of the Subject Building.

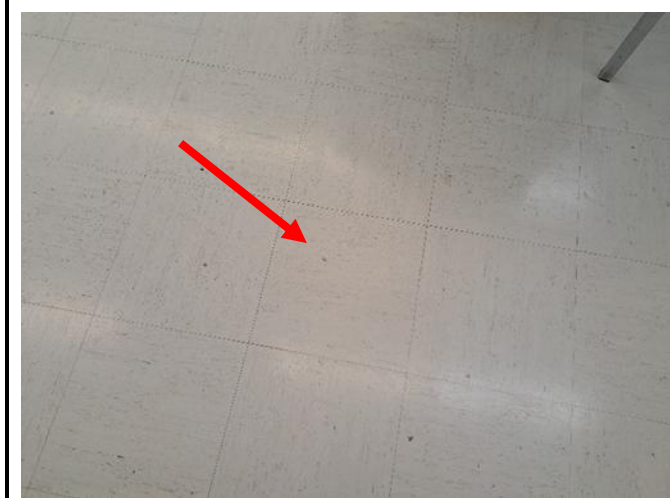
| Hazardous Material | Findings |
|---|---|
| | Vinyl Floor Tiles - 12"x12", off-white with dark streaks (WSP, 2016) previously collected within Classroom 310A were identified to contain <b>3.3% Chrysotile</b> asbestos by laboratory analysis. At the time of site visit approximately 1,500 ft <sup>2</sup> of the asbestos containing off-white with dark streaks vinyl floor tiles were observed to be in good condition. |

**Photo 9:** View of the asbestos-containing 12”x12” off-white with dark streaks vinyl floor tiles observed to be in good condition within Room 203.

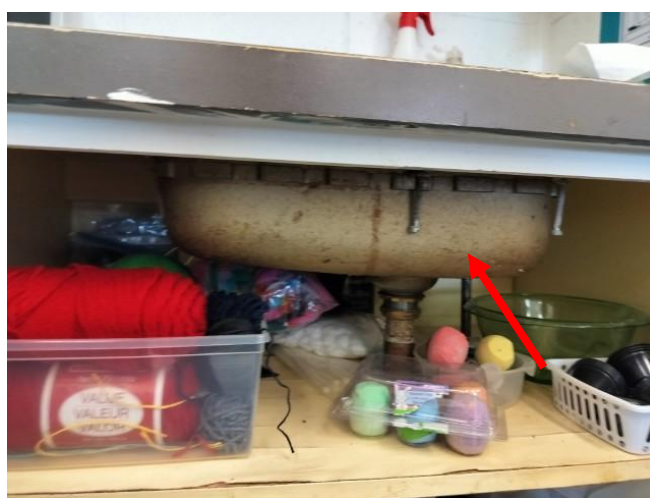
| Hazardous Material | Findings |
|---|---|
| | Gold Sink Coating (S2S, 2019) previously collected within the kitchen 232 was identified to contain <b>8% Chrysotile</b> asbestos by laboratory analysis. At the time of site visit 4 sinks with asbestos containing Gold Sink Coatings were observed to be in good condition within Classrooms 102, 200, and 203. |

**Photo 10:** View of asbestos containing gold sink coating (see arrow) observed to be in good condition within Room 203
