# Designated Substances Survey

**St. Paul Catholic  
Elementary School**

**1101 Hilliard Street,  
Peterborough, Ontario**

January 22, 2026

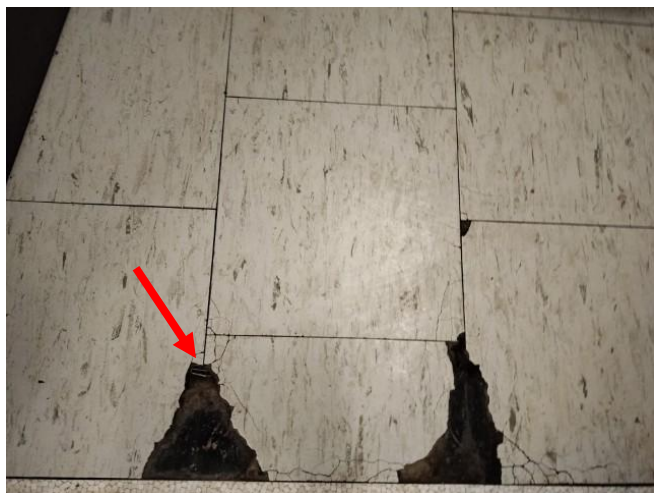
| Hazardous Material | Findings |
|---|---|
| | <p>12"x12" beige vinyl floor tiles with grey streaks (WSP, 2016) previously collected from various Classrooms and the Library Storage Room was identified to contain <b>1.1% Chrysotile asbestos</b> by laboratory analysis. At the time of site visit approximately 5,000 ft<sup>2</sup> of the asbestos containing beige vinyl floor tiles with grey streaks were observed to be in good condition within the following locations:</p> <ul style="list-style-type: none"> <li>• Storage 24A;</li> <li>• Storage 104 and 105;</li> <li>• Reception Room 113;</li> <li>• North Storage/Electrical Room; and</li> <li>• Rooms 117, 118, 203, 204, 205, 206, 207, 208, and 209.</li> </ul> <p>Additionally, the asbestos containing beige vinyl floor tiles with grey streaks were noted to be in fair condition within the following locations: 1 ft<sup>2</sup> in Staffroom 203, 1 ft<sup>2</sup> in Classroom 117, and 2 ft<sup>2</sup> in Custodial Room 206.</p> <p>White textured coating (WSP, 2016) previously collected from Classrooms 106, 12, 13, Staff Room, and Health Room was identified to contain <b>1.5% Chrysotile asbestos</b> by laboratory analysis. Based on this homogenous grouping, all white textured coating within the Subject Building is considered to be asbestos containing. At the time of site visit approximately 2,400 ft<sup>2</sup> of the asbestos containing white textured coating was observed to be in good condition and 2 ft<sup>2</sup> was noted to be in fair condition within the Boiler Room.</p> <p>Grey plaster coating (WSP, 2016) previously collected from Classrooms 106, 12, 13, Staff Room, and Health Room was identified to contain <b>1.8% Chrysotile asbestos</b> by laboratory analysis. Based on this homogenous grouping, all grey plaster coating finishes within the Subject Building are considered to be asbestos containing. At the time of site visit approximately 820 ft<sup>2</sup> of the asbestos containing grey plaster wall/ceiling finishes were observed to be in good condition and 22 ft<sup>2</sup> were noted to be in fair condition within Staffroom 31 due to penetrations through the plaster ceiling created for ceiling tile support wires.</p> <p>Beige vinyl sheet flooring (WSP, 2016) previously collected from the Corridors was identified to contain <b>20% Chrysotile asbestos</b> by laboratory analysis. At the time of site visit approximately 1,600 ft<sup>2</sup> of the asbestos containing beige vinyl sheet flooring was observed to be in good condition with the following locations noted to be in fair condition: 1 ft<sup>2</sup> in Corridor 110, 1 ft<sup>2</sup> in Corridor 120, and 4 ft<sup>2</sup> in Corridor 201.</p> |

**Photo 1:** View of the asbestos-containing 12"x12" beige vinyl floor tiles with grey streaks (see arrow) observed to be in fair condition within Custodian Room 206.

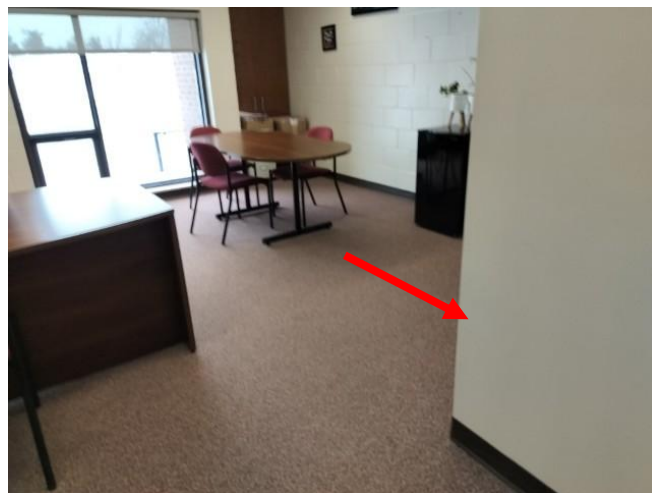
| Hazardous Material | Findings |
|---|---|
| | Drywall joint compound (WSP, 2016) previously collected throughout the Subject Building was identified to contain <b>1.2% Chrysotile asbestos</b> by laboratory analysis. Based on this homogenous grouping, all drywall joint compound and associated drywall finish within the Subject Building are considered to be asbestos containing. At the time of site visit the asbestos containing drywall joint compound and associated drywall finishes was observed to be in good condition throughout the Subject Building except for: <ul style="list-style-type: none"> <li>• Approximately 0.5 square feet in fair condition within Washroom 14; and</li> <li>• Approximately 2 square feet in fair condition within Washroom 20.</li> </ul> |

**Photo 2:** View of the drywall finishes with associated asbestos containing drywall joint compound (see arrow) observed to be in good condition within the Principal Room.

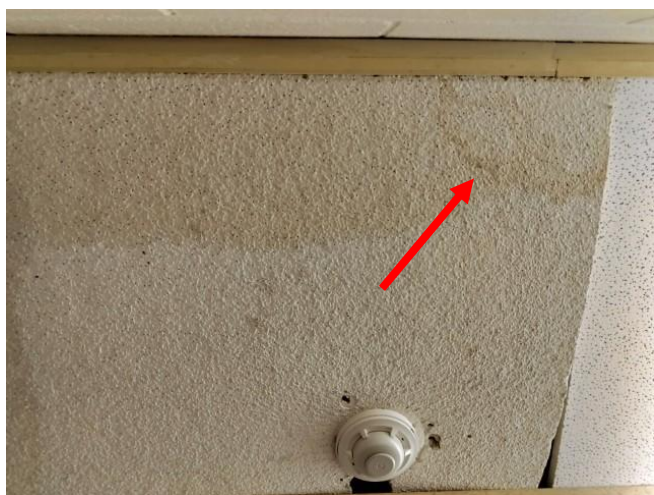
| Hazardous Material | Findings |
|---|---|
| Asbestos | 2' x 4' white textured ceiling tiles (Sample Nos. ACT-01a to ACT-01c) collected within the Custodian Storage Room 115 were identified to contain <b>5% Amosite asbestos</b> by laboratory analysis. At the time of site visit approximately 40 ft <sup>2</sup> the asbestos containing textured ceiling tiles were observed to be in good condition within the Custodian Storage Room 115 and 203 and 10 ft <sup>2</sup> were observed to be in fair condition within the Custodian Storage Room 115 and 203 due to water staining. |

**Photo 3:** View of the asbestos containing 2' x 4' white textured ceiling tiles (see arrow) observed to be in fair condition in the Custodian Storage Room 115.

- 2' x 4' white textured ceiling tiles (if an area less than 7.5 m<sup>2</sup> is to be disturbed).
- 2) S2S recommends that the following asbestos containing materials identified in Table 2 be managed in place or removed following Type 2 asbestos abatement procedures in accordance with O. Reg 278/05:

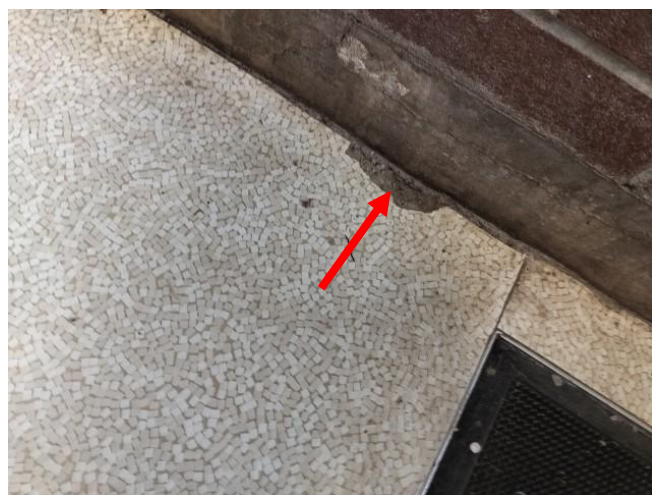
**Photo 4:** View of the asbestos containing beige vinyl sheet flooring (see arrow) observed in fair condition within the Corridor 110 near the Main Entrance.

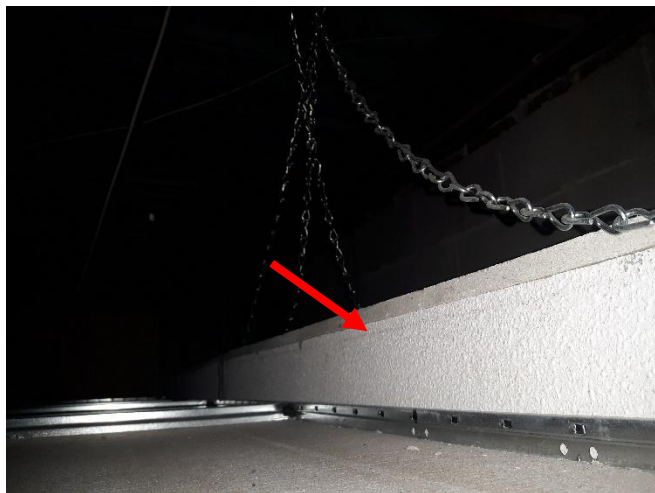
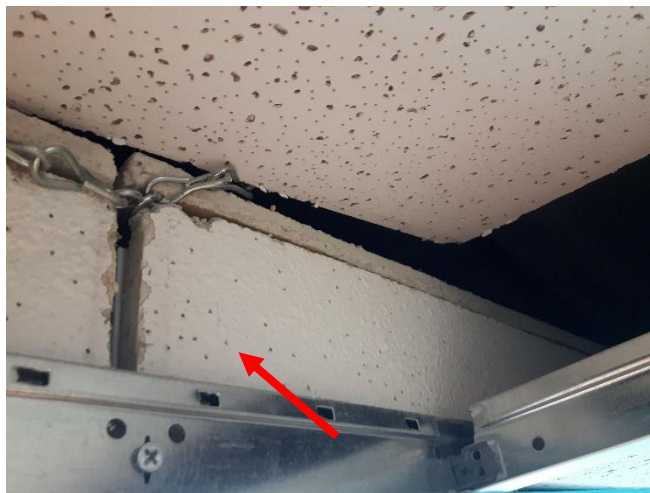
| Hazardous Material | Findings |
|---|---|
| | Insulating ceiling panels (Jacques Whitford, 2008) previously collected on light fixtures in Room 210 was identified to contain <b>8% Chrysotile asbestos</b> by laboratory analysis. At the time of site visit asbestos containing insulating ceiling panels were observed to be in good condition throughout Room 210 and are presumed to be located above the drop ceiling elsewhere throughout the Subject Building. |

**Photo 5:** View of the asbestos containing insulation ceiling panels (see arrow) observed to be in good condition around the light fixtures and above the drop ceiling within Room 210.

**Photo 6:** Additional view of the asbestos containing insulation ceiling panels (see arrow) observed to be in good condition around the light fixtures and above the drop ceiling within Room 210.

| Specific Location | Material | Acronym on Drawing | Quantity | Friable /Non-Friable | % and Type of ACM | Condition | Response Action Priority | Comments |
|---|---|---|---|---|---|---|---|---|
| Throughout Subject Building, Above Drop Ceiling | Insulating Ceiling Panels on Light Fixtures | N/A | Not Estimated | Friable | 8% Amosite (Jacques Whitford,2008) | Good | Priority 3 | Jacques Whitford report (2008) not available for review by S2S. Material observed in Room 210 during 2025 Assessment, however, is presumed to be located throughout. Manage in Place. |

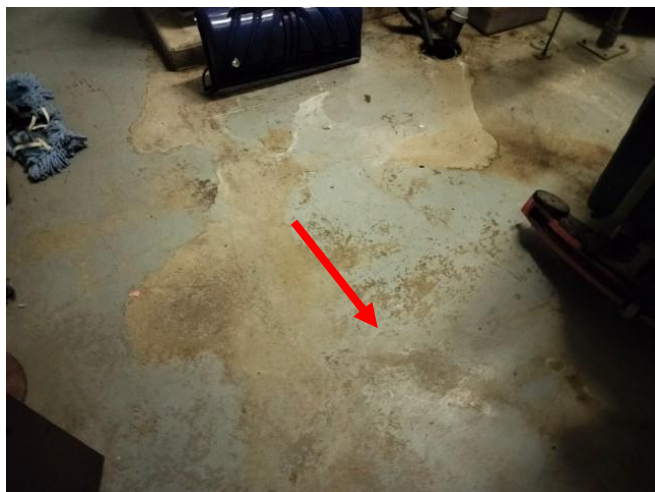
| Hazardous Material | Findings |
|---|---|
| Lead | <p>Grey paint (WSP, 2016) observed on the Boiler Room floor was previously identified to contain <b>0.010% lead</b> content by dry weight. At the time of the current site visit the low-level lead containing grey paint was observed to be in fair condition.</p> <p>Black paint (WSP, 2016) observed on door frames throughout the Subject Building was previously identified to contain <b>0.022% lead</b> content by dry weight. At the time of the current site visit the low-level lead containing black paint was observed to be in good condition.</p> <p>Brown paint (WSP, 2016) observed on the exterior doors throughout the Subject Building was previously identified to contain <b>0.96% lead</b> content by dry weight. At the time of the current site visit the lead containing brown paint was observed to be in fair condition.</p> <p>Lead may also be present in electronic components (e.g., wiring connections, wire bundles, etc.), plumbing solder, roof flashing, noise baffles, emergency lighting batteries, and cast-iron piping gaskets (i.e., bell &amp; spigots). Where present within the Subject Building, they are presumed to be lead-containing.</p> |

**Photo 7:** View of the low-level lead containing grey paint (see arrow) observed to be in fair condition on the floor within the Boiler Room.

| Floor Level | Sample Number | Functional Space | Description | Consultant/Year | Lead Content by Weight (%)* | Condition | Comments |
|---|---|---|---|---|---|---|---|
| 1 | 112-L1 | Boiler room floor | Grey paint | WSP/2016 | 0.010 | Fair | Lead containing paint. Recommended that paint be abated or stabilized with the application of a new paint over top. |

- 4) Based on visual observations, the previously identified lead containing paints observed during the site visit were identified to be in good condition with the exception of the low-level lead containing grey paint on the floor in the Boiler Room in fair condition and the lead containing brown paint on the exterior doors throughout the Subject Building in fair condition. Paints with similar texture and appearance that are present in other areas of the Subject Building should be presumed to contain similar concentrations of lead. Lead may also be present in paints not sampled, electronic components (e.g., wiring connections, wire bundles, etc.), plumbing solder, roof flashing, noise baffles, emergency lighting batteries, and cast-iron piping gaskets (i.e., bell & spigots). Where present within the Subject Building, they are presumed to be lead-containing. Refer to Appendix E for the previous lead paint bulk sampling locations, results, and current condition.

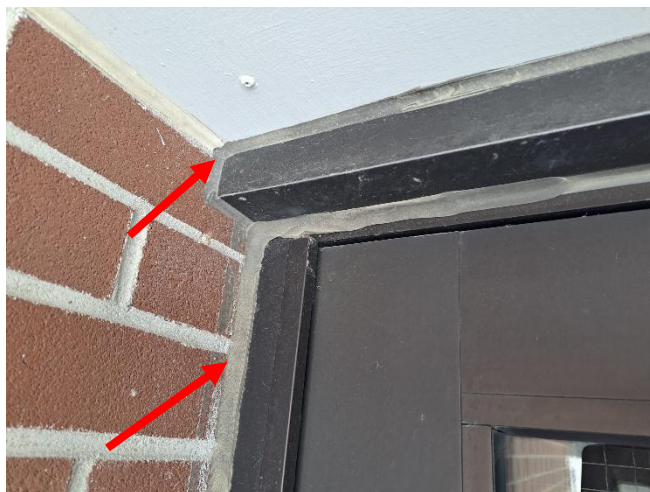
**Photo 8:** View of the non-asbestos containing exterior grey caulking (see right arrow) and brick mortar (see left arrow) observed to be in good condition throughout the Subject Building.

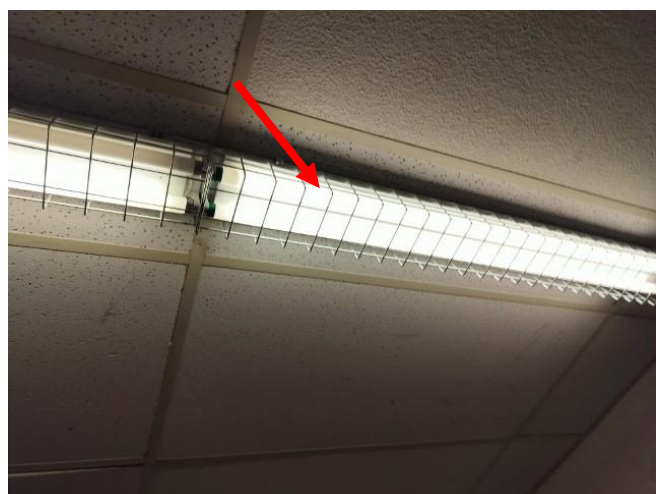
| Hazardous Material | Findings |
|---|---|
| Mercury | <p>Mercury in the form of vapour was observed to be present within fluorescent light tubes observed throughout the Subject Building. Liquid mercury is also suspected to be present within the wall mounted thermometers observed within the Subject Building. At the time of the site visit, all visually observed fluorescent light tubes and wall mounted thermostats were noted to be intact and in good condition within the Subject Building.</p> |

**Photo 9:** View of the mercury containing fluorescent light tubes (see arrow) observed to be in good condition throughout the Subject Building.

- 5) Mercury in the form of vapour was observed to be present within the fluorescent light tubes observed throughout the Subject Building. Liquid mercury is also suspected to be present within the thermostats observed throughout the Subject Building. At the time of the site visit, all visually observed fluorescent light tubes and thermostats, where accessible, were noted to be intact and in good condition. It is recommended that disposal of out-of-service fluorescent light tubes, thermostats, or any other mercury containing materials or equipment be completed in accordance with O. Reg. 490/09 and O. Reg. 347.

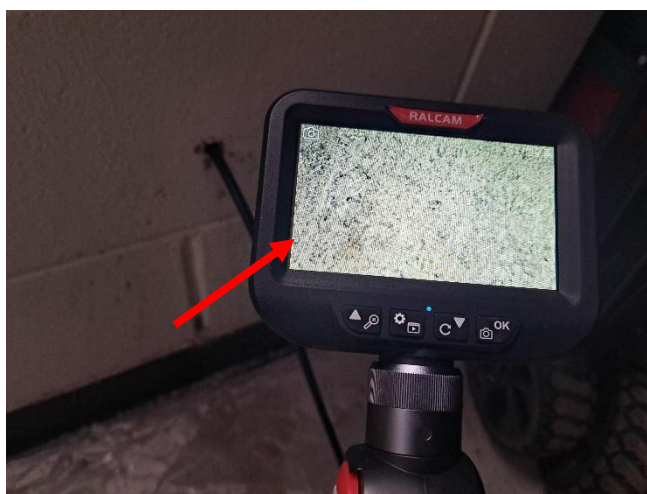
| Hazardous Material | Findings |
|---|---|
| | <p>During the site visit, wall cavities were investigated throughout representative locations within the 1966 section of the Subject Building to determine the presence or absence of vermiculite. Drill holes, where required, were made to provide visual access with a borescope. Upon completion of the investigation, it was determined that no evidence of vermiculite materials was observed or are presumed to be present within the Subject Building.</p> <p>Although not observed during the inspection, additional ACMs may be present in visually inaccessible areas of the Subject Building.</p> <p>Refer to Appendix D for the S2S Annual ACMs Inspection Summary Table and Appendix E for the previous asbestos bulk sample locations and results.</p> |

**Photo 10:** View of the concrete block wall during the vermiculite investigation and drilling activities (see arrow) within the library.
