# Designated Substances Survey

**Immaculate Conception  
Catholic Elementary  
School**

**76 Robinson Street,  
Peterborough, Ontario**

January 21, 2026

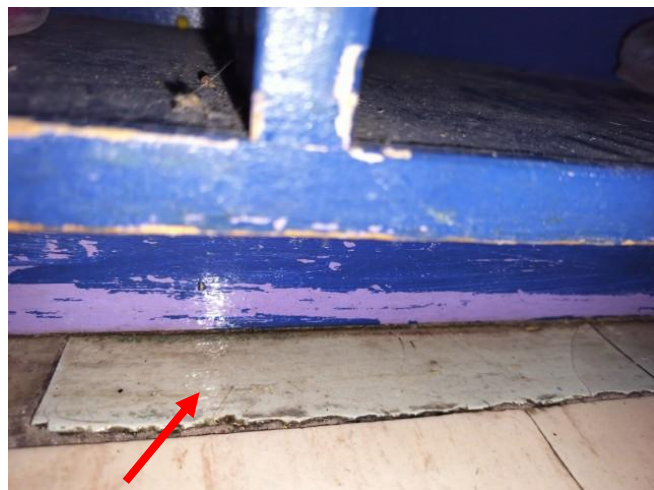
| Hazardous Material | Findings |
|---|---|
| | <p>9" x 9" blue and grey vinyl floor tiles (WSP, 2016) previously collected from Room 204 were identified to contain <b>0.75% Chrysotile</b> asbestos by laboratory analysis. At the time of site visit, approximately 3 ft<sup>2</sup> of the asbestos containing blue and grey vinyl floor tiles were observed to be in fair condition and approximately 10 ft<sup>2</sup> were observed to be in good condition beneath the shelving unit.</p> |

**Photo 1:** View of the asbestos containing 9"x9" blue/grey vinyl floor tiles (see arrow) observed to be in fair condition beneath the shelving unit within Classroom 204.

- 1) S2S recommends that the following asbestos containing materials identified in Table 2 be managed in place or removed following Type 1 asbestos abatement procedures in accordance with O. Reg 278/05:
  - Vinyl floor tiles (if wetted down and using hand-held tools);
  - Transite cement panels (if removed without damage); and
  - Gold sink coating.

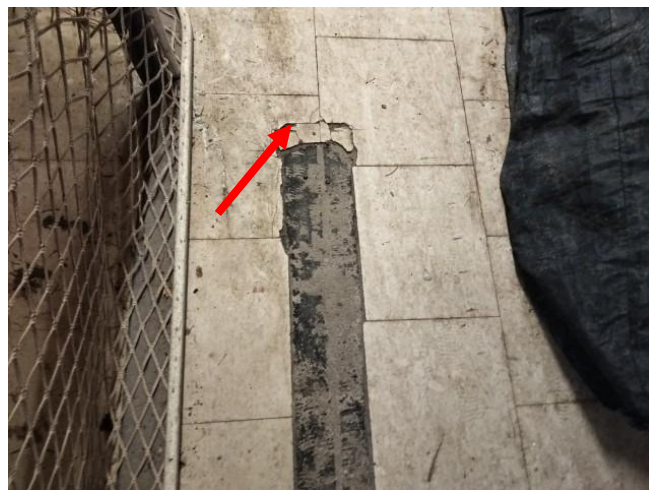
| Hazardous Material | Findings |
|---|---|
| | <p>12"x12" beige vinyl floor tiles with light and dark flecks (Jacques Whitford, 2008) previously collected from Storage Room 116A were identified to contain <b>3% Chrysotile</b> asbestos by laboratory analysis. At the time of the site visit, approximately 20 ft<sup>2</sup> of asbestos containing beige vinyl floor tiles with light and dark flecks were observed to be in fair condition and approximately 224 ft<sup>2</sup> were observed to be in good condition.</p> |

**Photo 2:** View of the asbestos containing 12"x12" beige vinyl floor tiles with light and dark flecks (see arrow) observed to be in fair condition within Storage Room 116A.

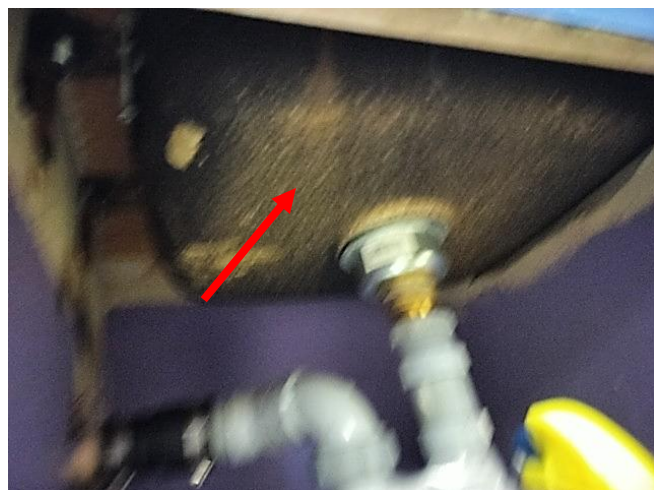
| Hazardous Material | Findings |
|---|---|
| | <p>Gold sink coating (S2S, 2019) present within Classrooms 114, 115, 204 and 205 was identified to contain <b>8% Chrysotile</b> asbestos by laboratory analysis. At the time of the site visit, approximately 16 ft<sup>2</sup> (4 sinks) of asbestos containing gold sink coating was observed to be in good condition.</p> |

**Photo 3:** View of the asbestos containing gold sink coating (see arrow) observed to be in good condition within Classroom 115.

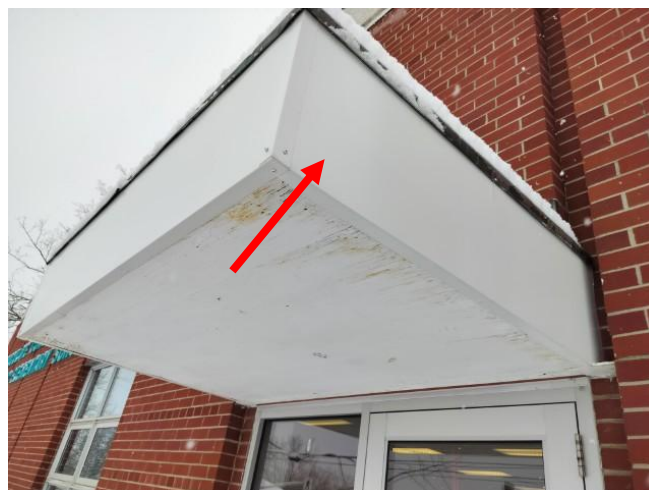
| Hazardous Material | Findings |
|---|---|
| | <p>Transite cement panels (Jacques Whitford, 2008) previously collected from the exterior soffits and sidings of the Subject Building were identified to contain <b>30% Chrysotile</b> asbestos by laboratory analysis. At the time of the site visit, approximately 185 ft<sup>2</sup> of the asbestos containing Transite cement panels were observed to be in good condition on the south, east, and north soffits as well as on the south and north siding, with the exception of 10 ft<sup>2</sup> on the south soffit, 4 ft<sup>2</sup> on the south siding and 2 ft<sup>2</sup> on the north soffit which were observed to be in fair condition. The east soffit previously observed to be in poor condition was observed to be encapsulated.</p> |

**Photo 4:** View of the encapsulated asbestos containing cement board (see arrow) observed to be in good condition on east exterior soffits.

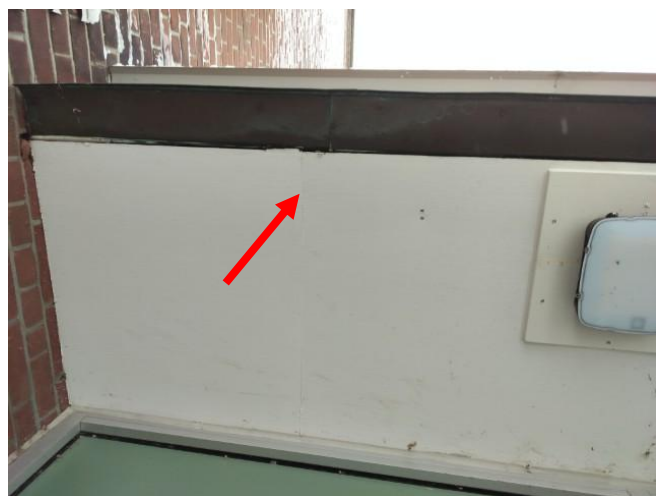
**Photo 5:** View of the asbestos containing cement board (see arrow) observed to be in fair condition at the exterior of Corridor 219.

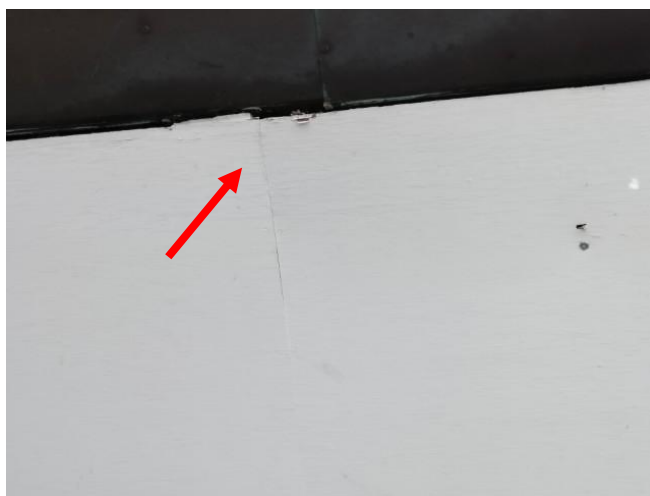
**Photo 6:** Additional close-up view of the asbestos containing cement board (see arrow) observed to be in fair condition at the exterior of Corridor 219.

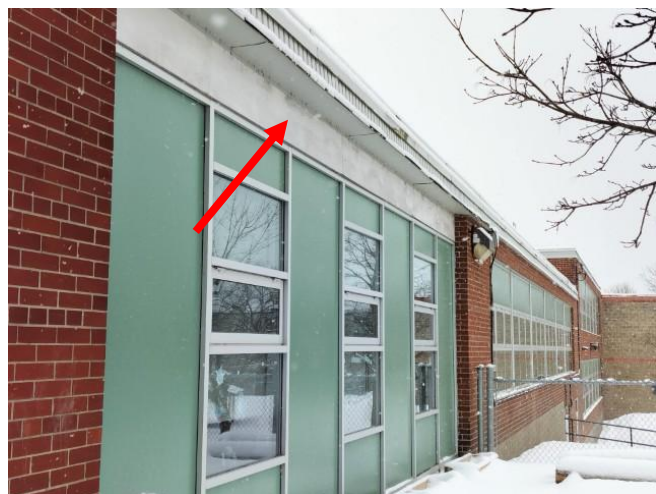
**Photo 7:** View of the asbestos containing cement board (see arrow) observed to be in good condition on siding near the Parking Lot of the Subject Building.

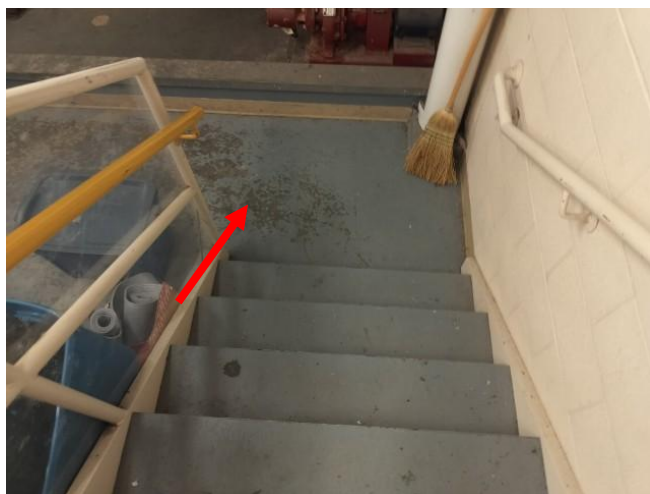
| Hazardous Material | Findings |
|---|---|
| Lead | Grey paint (WSP, 2016) observed on the concrete floor of the Mechanical Room was previously identified to contain <b>0.0084% lead</b> content by dry weight. At the time of the site visit, the low-level lead containing grey paint was observed to be in fair condition. |

**Photo 8:** View of the low-level lead containing grey paint (see arrow) observed to be in fair condition on the floor of the Mechanical Room.

| Floor Level | Sample Number | Functional Space | Description | Consultant/Year | Lead Content by Weight (%)* | Condition | Comments |
|---|---|---|---|---|---|---|---|
| 1 | 106-L1 | Mechanical room floor | Grey paint from floor | WSP/2016 | 0.0084 | Fair | Lead-containing paint. Recommended that paint be abated or stabilized with the application of a new paint over top. Manage in place. |

- 4) Paints identified in Table 2 above were found to contain detectible concentrations of lead. Based on visual observations during the DSS, the identified low-level lead containing paints noted in Table 2 were observed to be in good condition, with the exception of the fair condition grey paint within Mechanical Room and the fair condition blue/purple paint on the Stairwell railing. Paints with similar texture and appearance that are present throughout the Subject Building should be presumed to contain similar concentrations of lead. It is recommended that the fair condition paint be stabilized with fresh paint using appropriate worker protection.

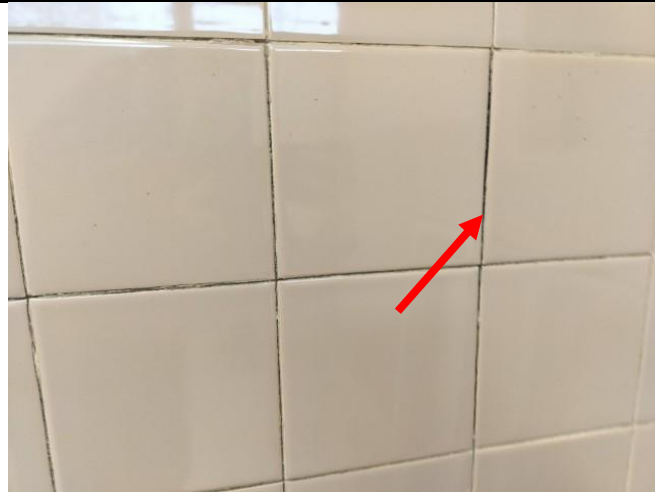
| <b>Hazardous Material</b> | <b>Findings</b> |
|---|---|
| Suspect Mould | No apparent water staining/damage was observed within the Subject Building at the time of the site visit, however visual suspect mould growth was identified on one acoustic ceiling tile outside of the Gymnasium and on approximately 4 linear feet of ceramic tile mortar within the Boy's Washroom. |

**Photo 9:** View of the visual suspect mould growth (see arrow) observed on the non-asbestos containing ceramic tile grout on the wall within the Boy's Washroom.

- 8) Evidence of visual suspect mould growth was identified on building finishes within the Subject Building and are detailed in Table 2. S2S recommends that apparent water-stained acoustic ceiling tiles be removed by trained maintenance staff and that the sources of all apparent water staining be investigated and repaired to prevent the development of mould growth. S2S also recommends that the visual suspect mould growth be removed following Level 1 mould abatement procedures in accordance with the EACC (2015) and CCA (2018) guidelines.

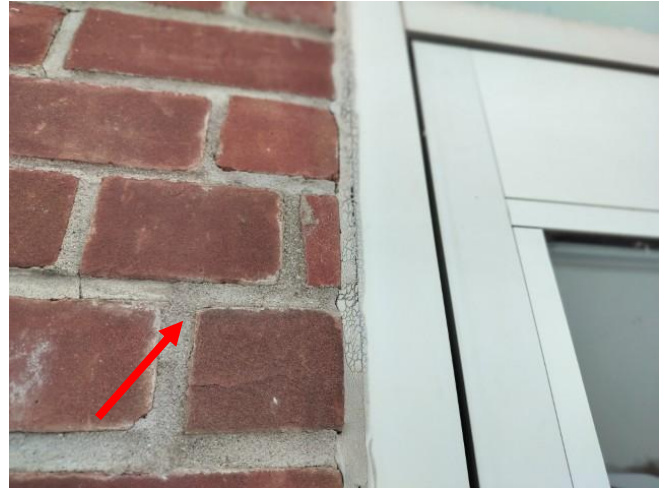
**Photo 10:** View of the non-asbestos containing brick mortar (see arrow) observed on the exterior walls throughout the Subject Building.

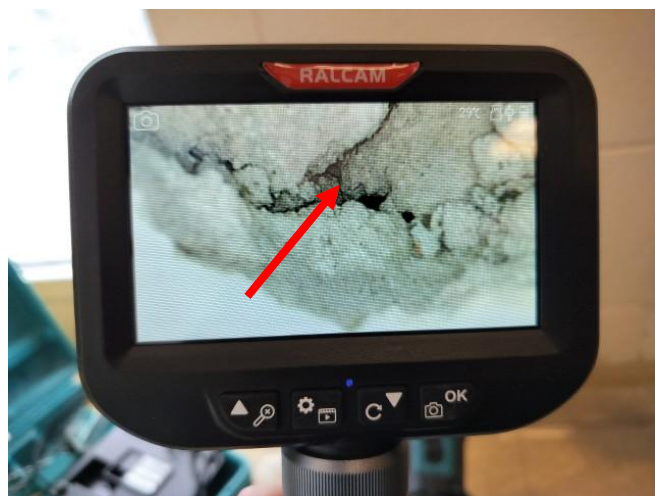
| Hazardous Material | Findings |
|---|---|
| | During the site visit, wall cavities were investigated throughout representative locations within the 1956 sections of the Subject Building to determine the presence or absence of vermiculite. Drill holes were made to provide visual access with a borescope. Upon completion of the investigation, it was determined that no evidence of vermiculite materials was observed or are presumed to be present within the Subject Building. |

**Photo 11:** View of the borescope (see arrow) observing within the drill hole conducted in Classroom 210 during the vermiculite investigation.

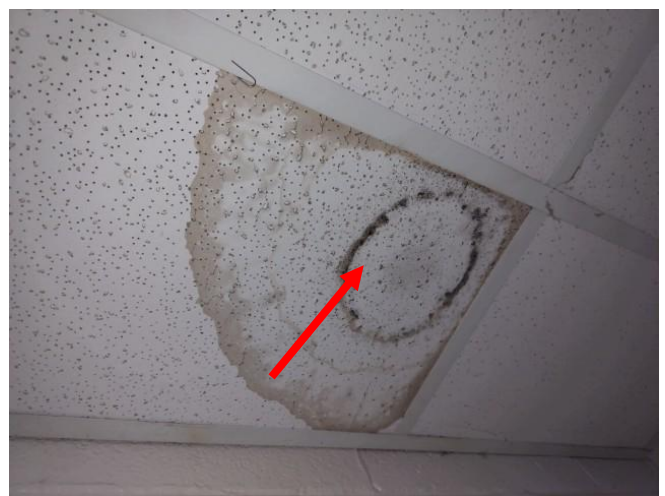
**Photo 12:** View of the visual suspect mould growth (see arrow) observed on the non-asbestos containing acoustic ceiling tile outside of the Gymnasium Door.
